# FLOOD INFORMATION MAP

STEPHENVILLE CROSSING/  
BLACK DUCK SIDING

STEPHENVILLE CROSSING/BLACK DUCK SIDING • NEWFOUNDLAND

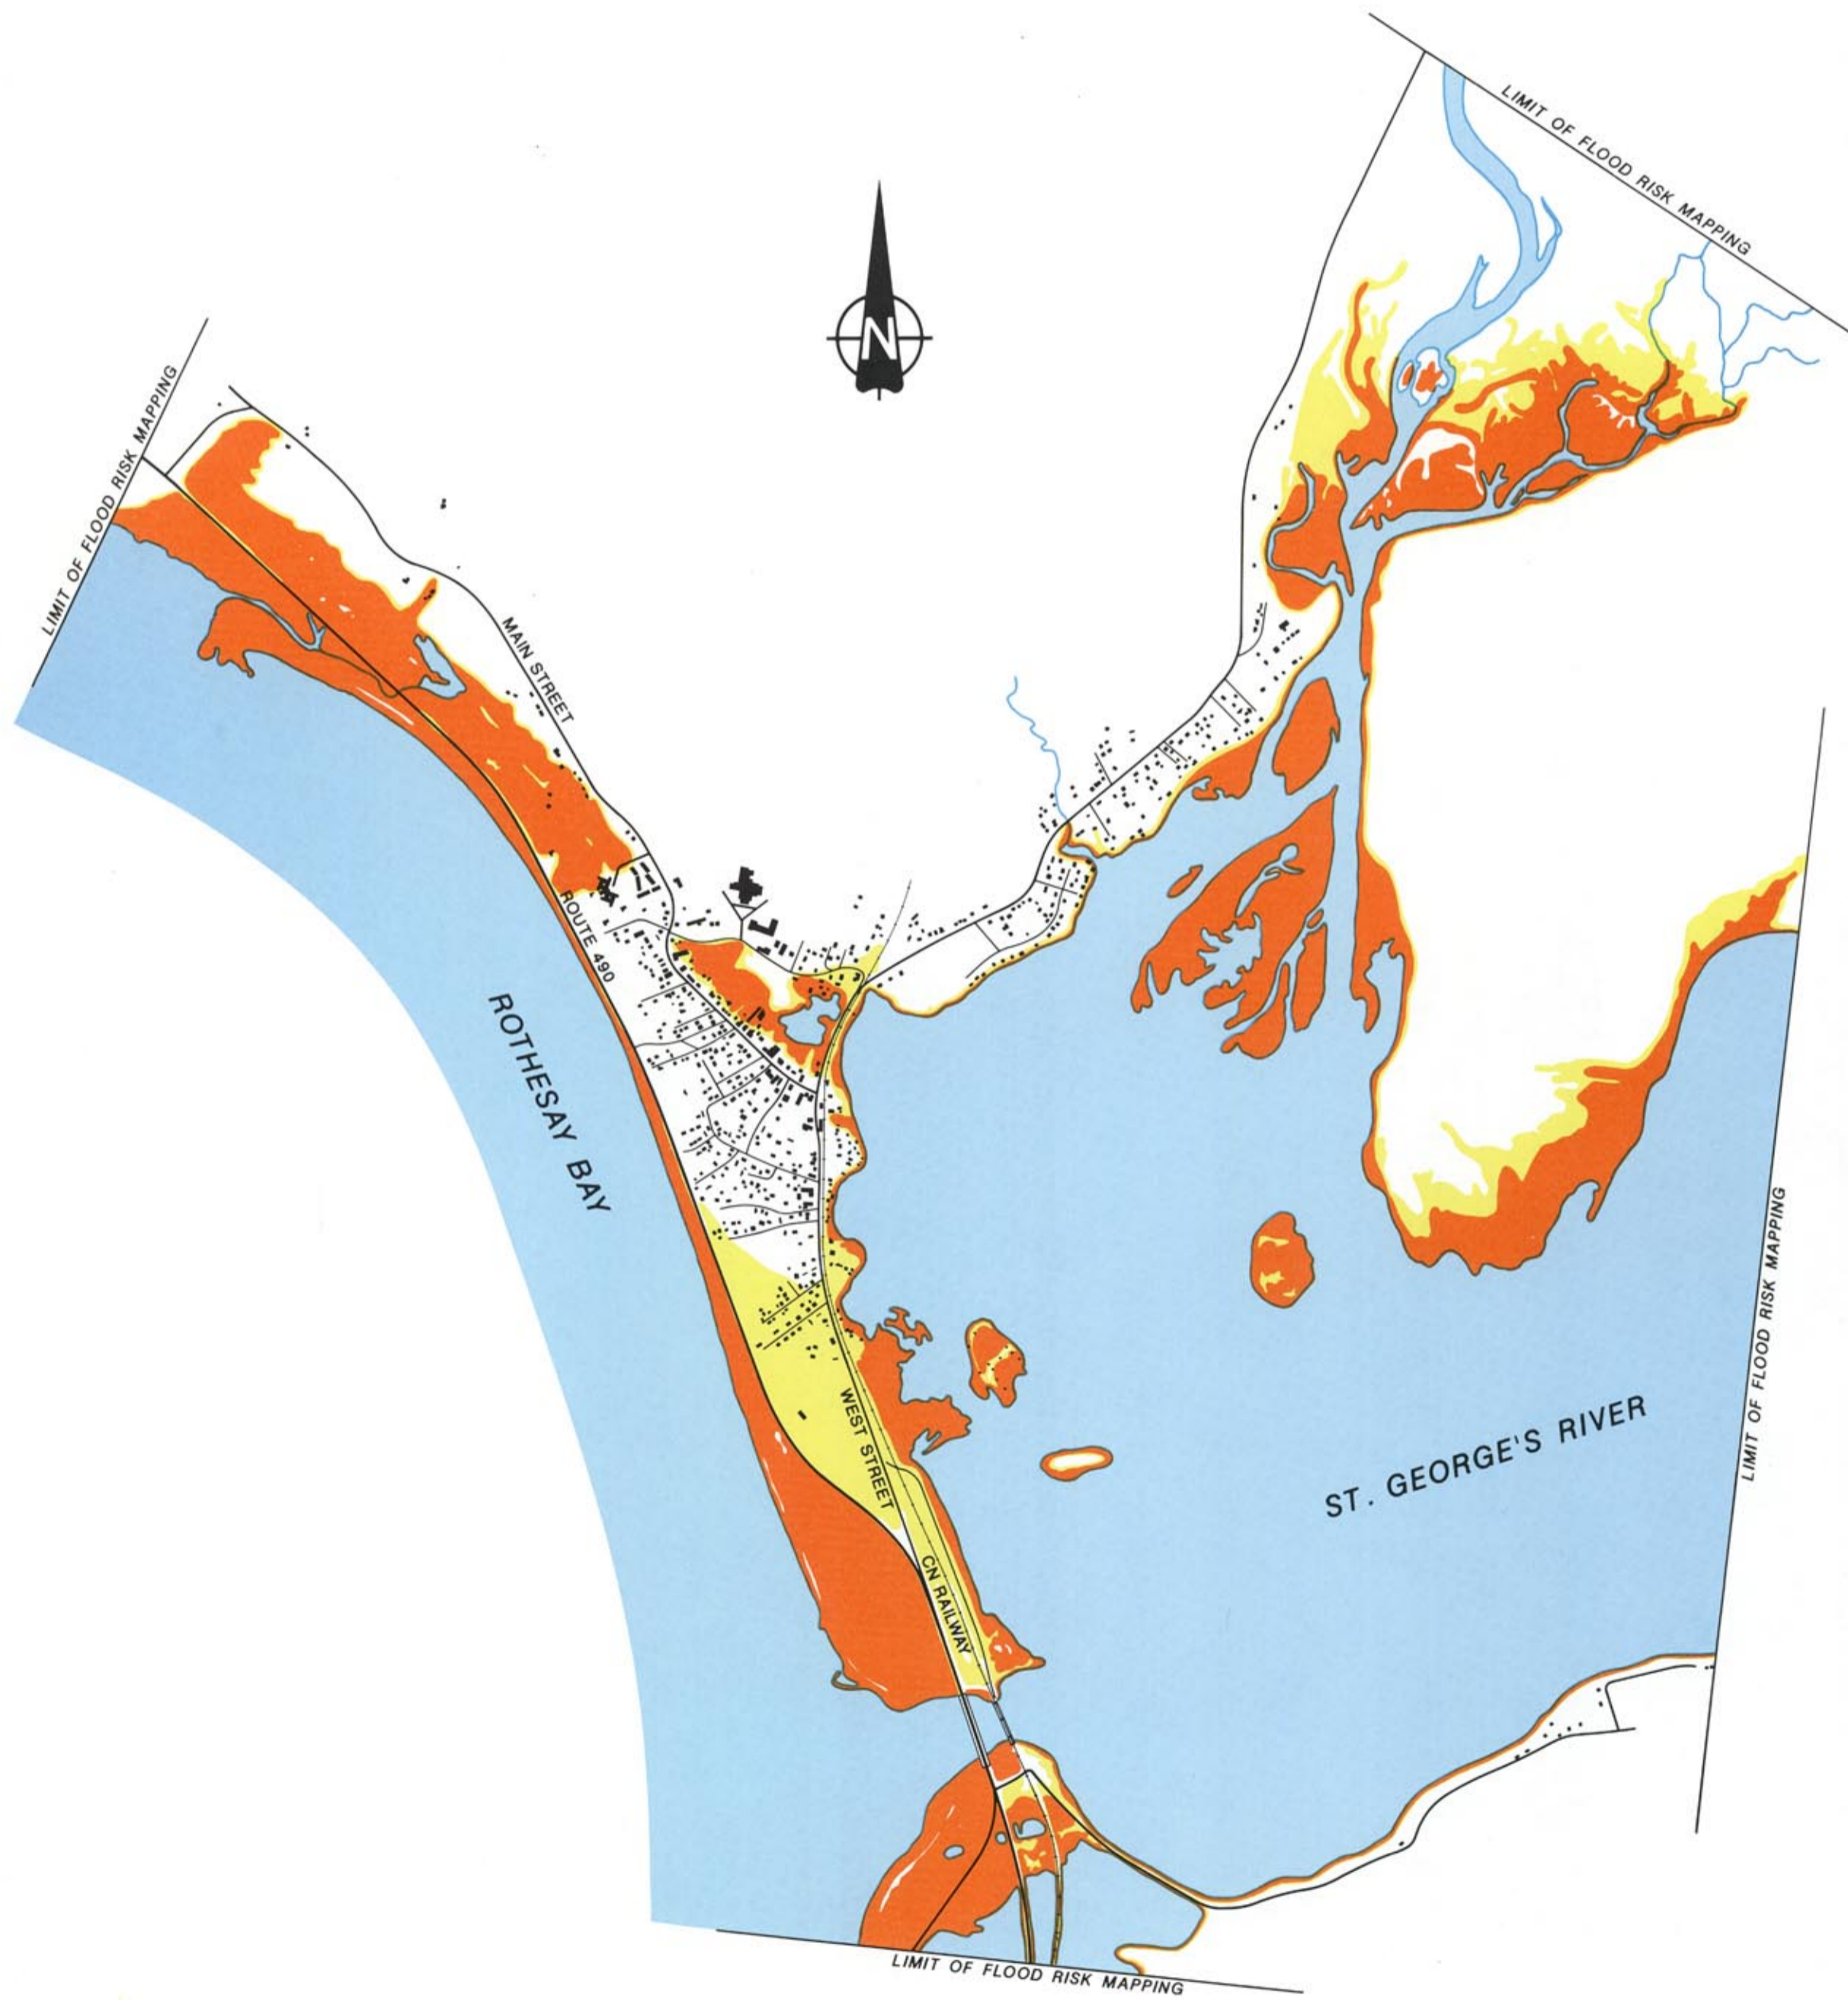
STEPHENVILLE CROSSING

A "designated floodway" (1:20 year flood zone) is the area subject to most frequent flooding. A "designated floodway fringe" (1:100 year flood zone) constitutes the remainder of the flood risk area. This generally receives less damage from flooding.

This is a map of the Stephenville Crossing/Black Duck Siding flood risk areas—showing areas prone to flooding—the "designated floodway" in orange and the "designated floodway fringe" area in yellow.
